# **FEASIBILITY STUDY FOR THE REMOVAL OF POMPTON DAM AND PEQUANNOCK DAM**

Ramapo State Forest  
Wayne, Pompton Lakes and Pequannock Townships  
Passaic and Morris Counties, NJ

**PROJECT NO. P1079-00**

**JUNE 2012**

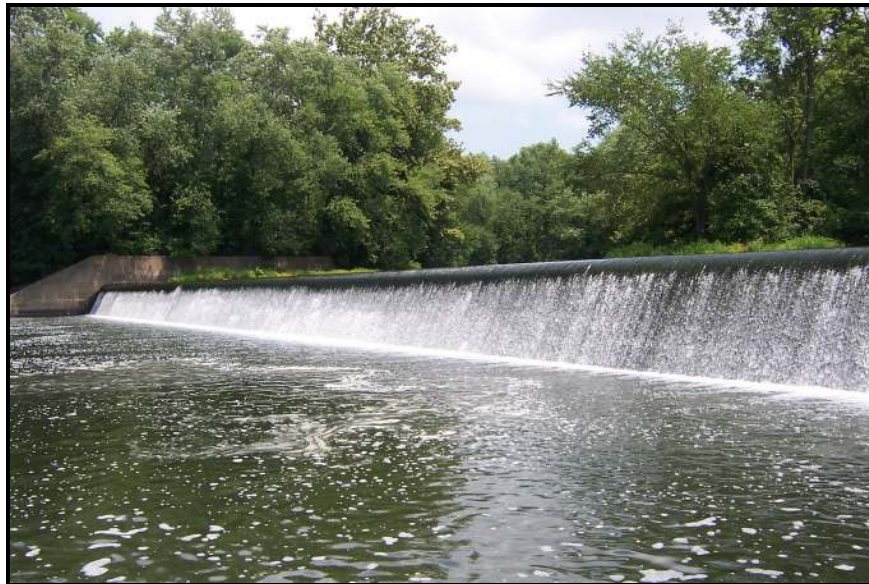
The spillway crest at Pompton Dam is at Elevation 174.6 feet and is 270 feet long. *All elevation data is referenced to 1988 North American Vertical Datum (NAVD) unless otherwise noted.* The spillway crest is about 6 feet above the normal downstream tailwater and about 13 feet above the bottom of the downstream stream channel. There is no known concrete apron on the downstream side of the dam.

The top of the training walls are at Elevation 183.1 feet. There is an earth embankment at the left abutment of the dam that is about 170 feet long.

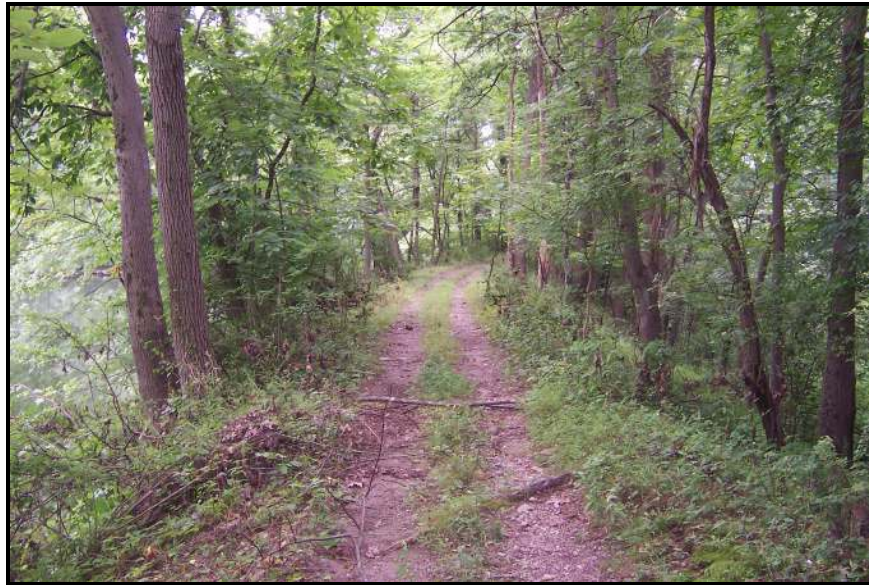
The right side of the dam consists of an earth embankment running along the right side of the Ramapo River that connects with the left side of the Pequannock Dam. The dike is about 2,400 feet long. The dike is severely eroded in many areas and the top of the dike varies from Elevation 180.9 feet to Elevation 183.2 feet.

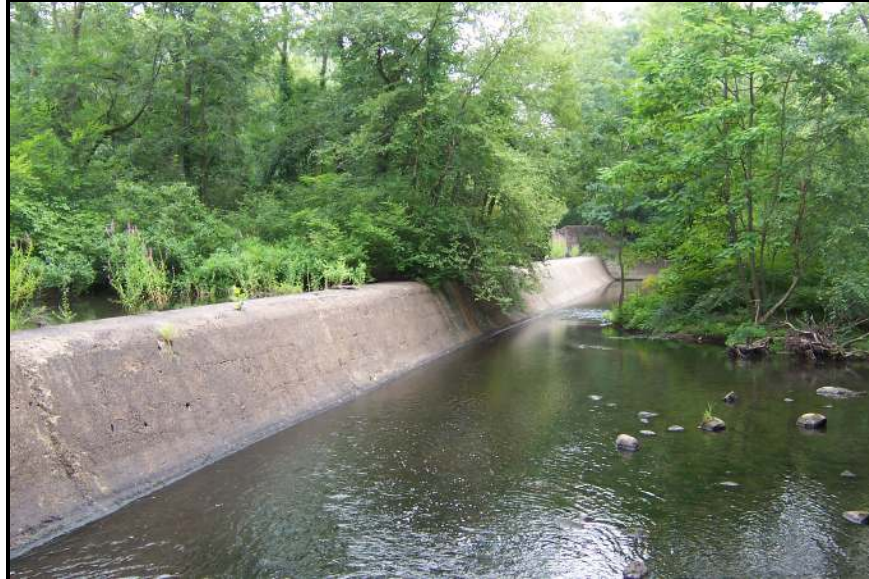
The spillway crest at Pequannock Dam is at Elevation 175.3 feet and is also 270 feet long. There is a 6-foot long notch at Elevation 174.3 on the right side of the spillway. Given the fact that the spillway crest is about 10 inches higher than the Pompton Dam crest, water flows through the notch only during normal flow conditions in the rivers and there is limited shallow flow in the downstream stream channel. There is also a concrete apron along the downstream toe of the spillway that is at Elevation 168.2 feet. Therefore, the spillway crest is 7.1 feet high.

The top of the training walls are at Elevation 183.9 feet. There is an earth embankment at the right abutment of the dam that is about 400 feet long. Tax maps show this earth embankment to be located on Block 902, Lot 3 in Pequannock Township which is privately held and the location of the North Jersey Equestrian Center LLC.

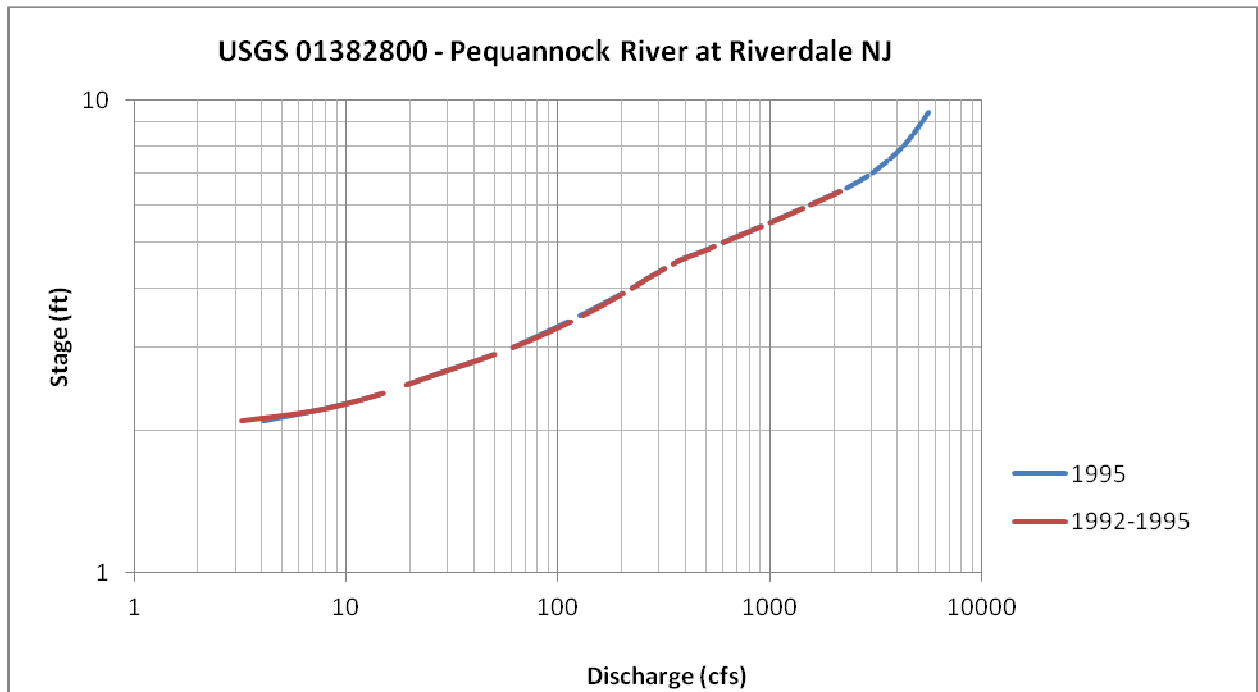
**Figure 9-1**  
**Stage-Discharge Rating Curves - USGS 01382800**

As shown on this figure, the rating curves for the two records are uniform for the varying flows. This equivalence in rating curves shows that the channel has been historically stable and there is no net flux in sediment transport occurring in the river.

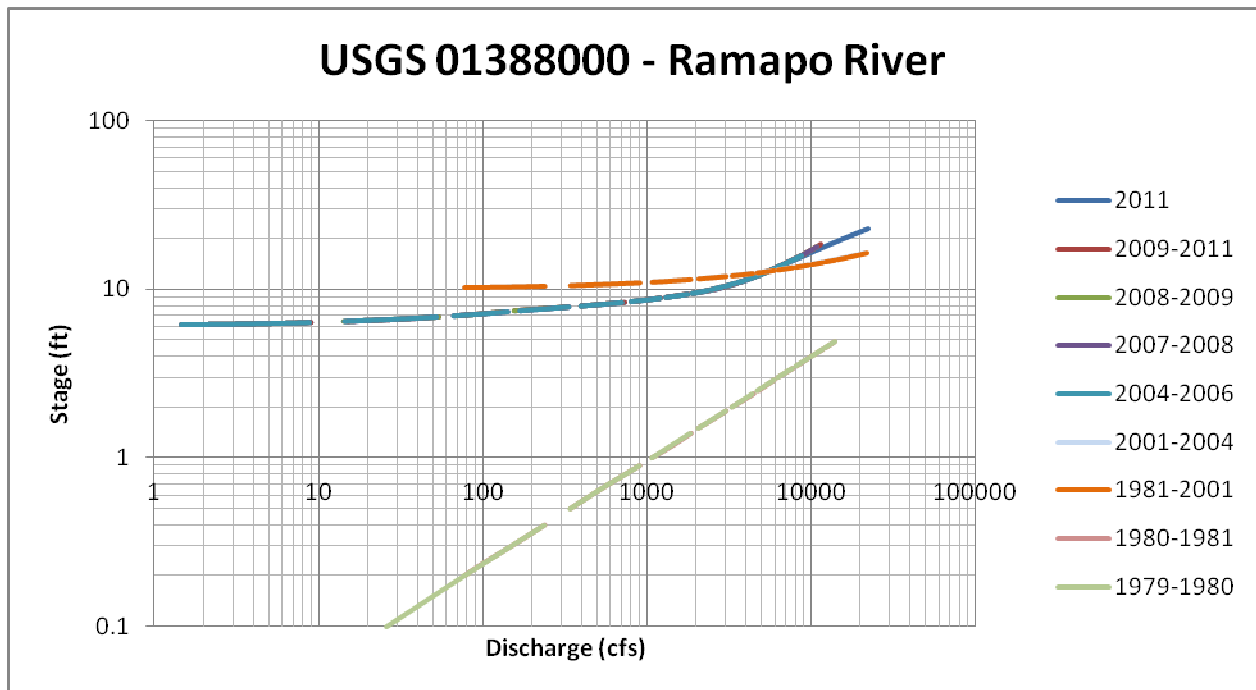
**Figure 9-2**  
**Stage-Discharge Rating Curves - USGS 01388000**

According to the USGS, the location of this gage was approximately 19.61 feet higher than its current elevation before 2004 and at a different location; additionally, this gage was approximately 29.61 feet higher prior to 1981. Due to this significant shift in location, the data shown on the above figure prior to 2004 was not considered in this evaluation.

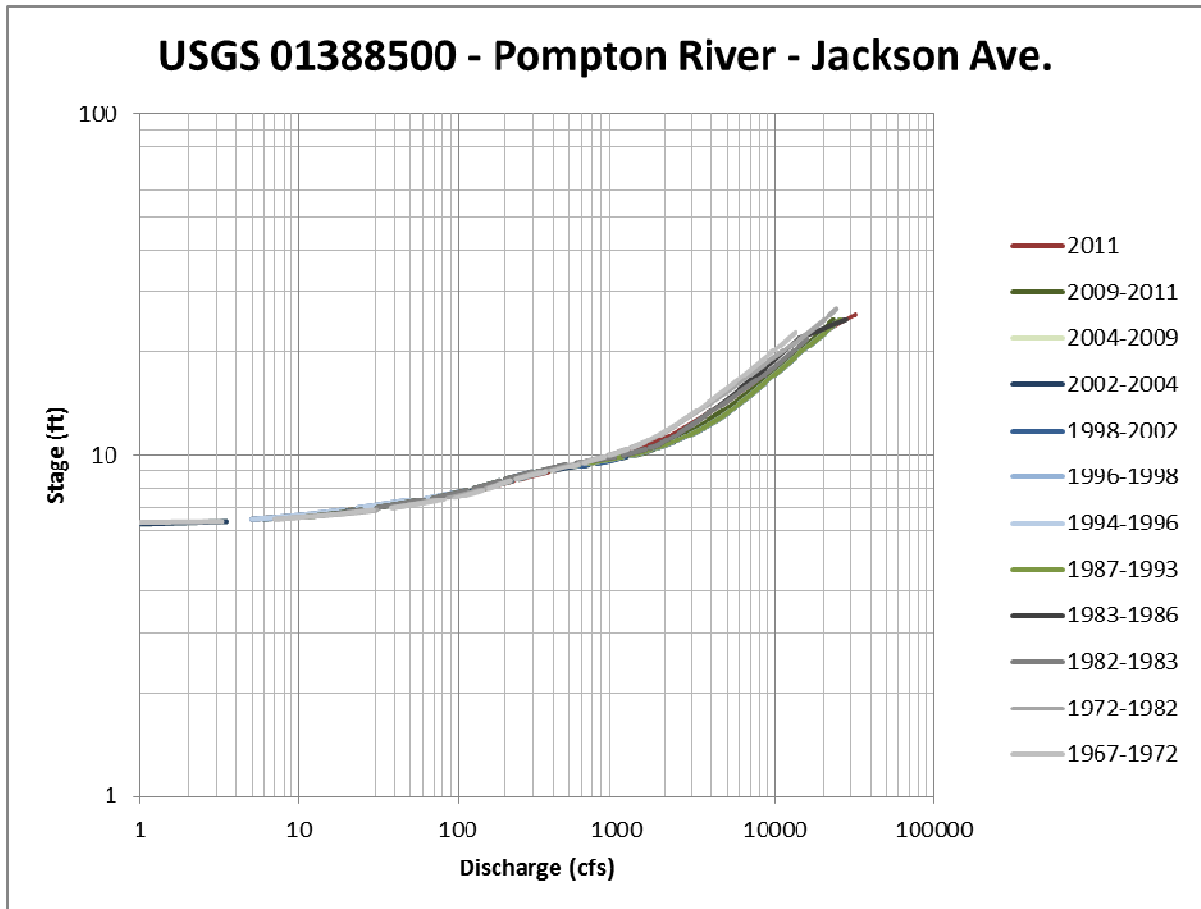
**Figure 9-3**  
**Stage-Discharge Rating Curves - USGS 01388500**

In general, there is no-net sediment aggregation or degradation occurring in the Pompton River to shift the long-term stability of the stream channel.

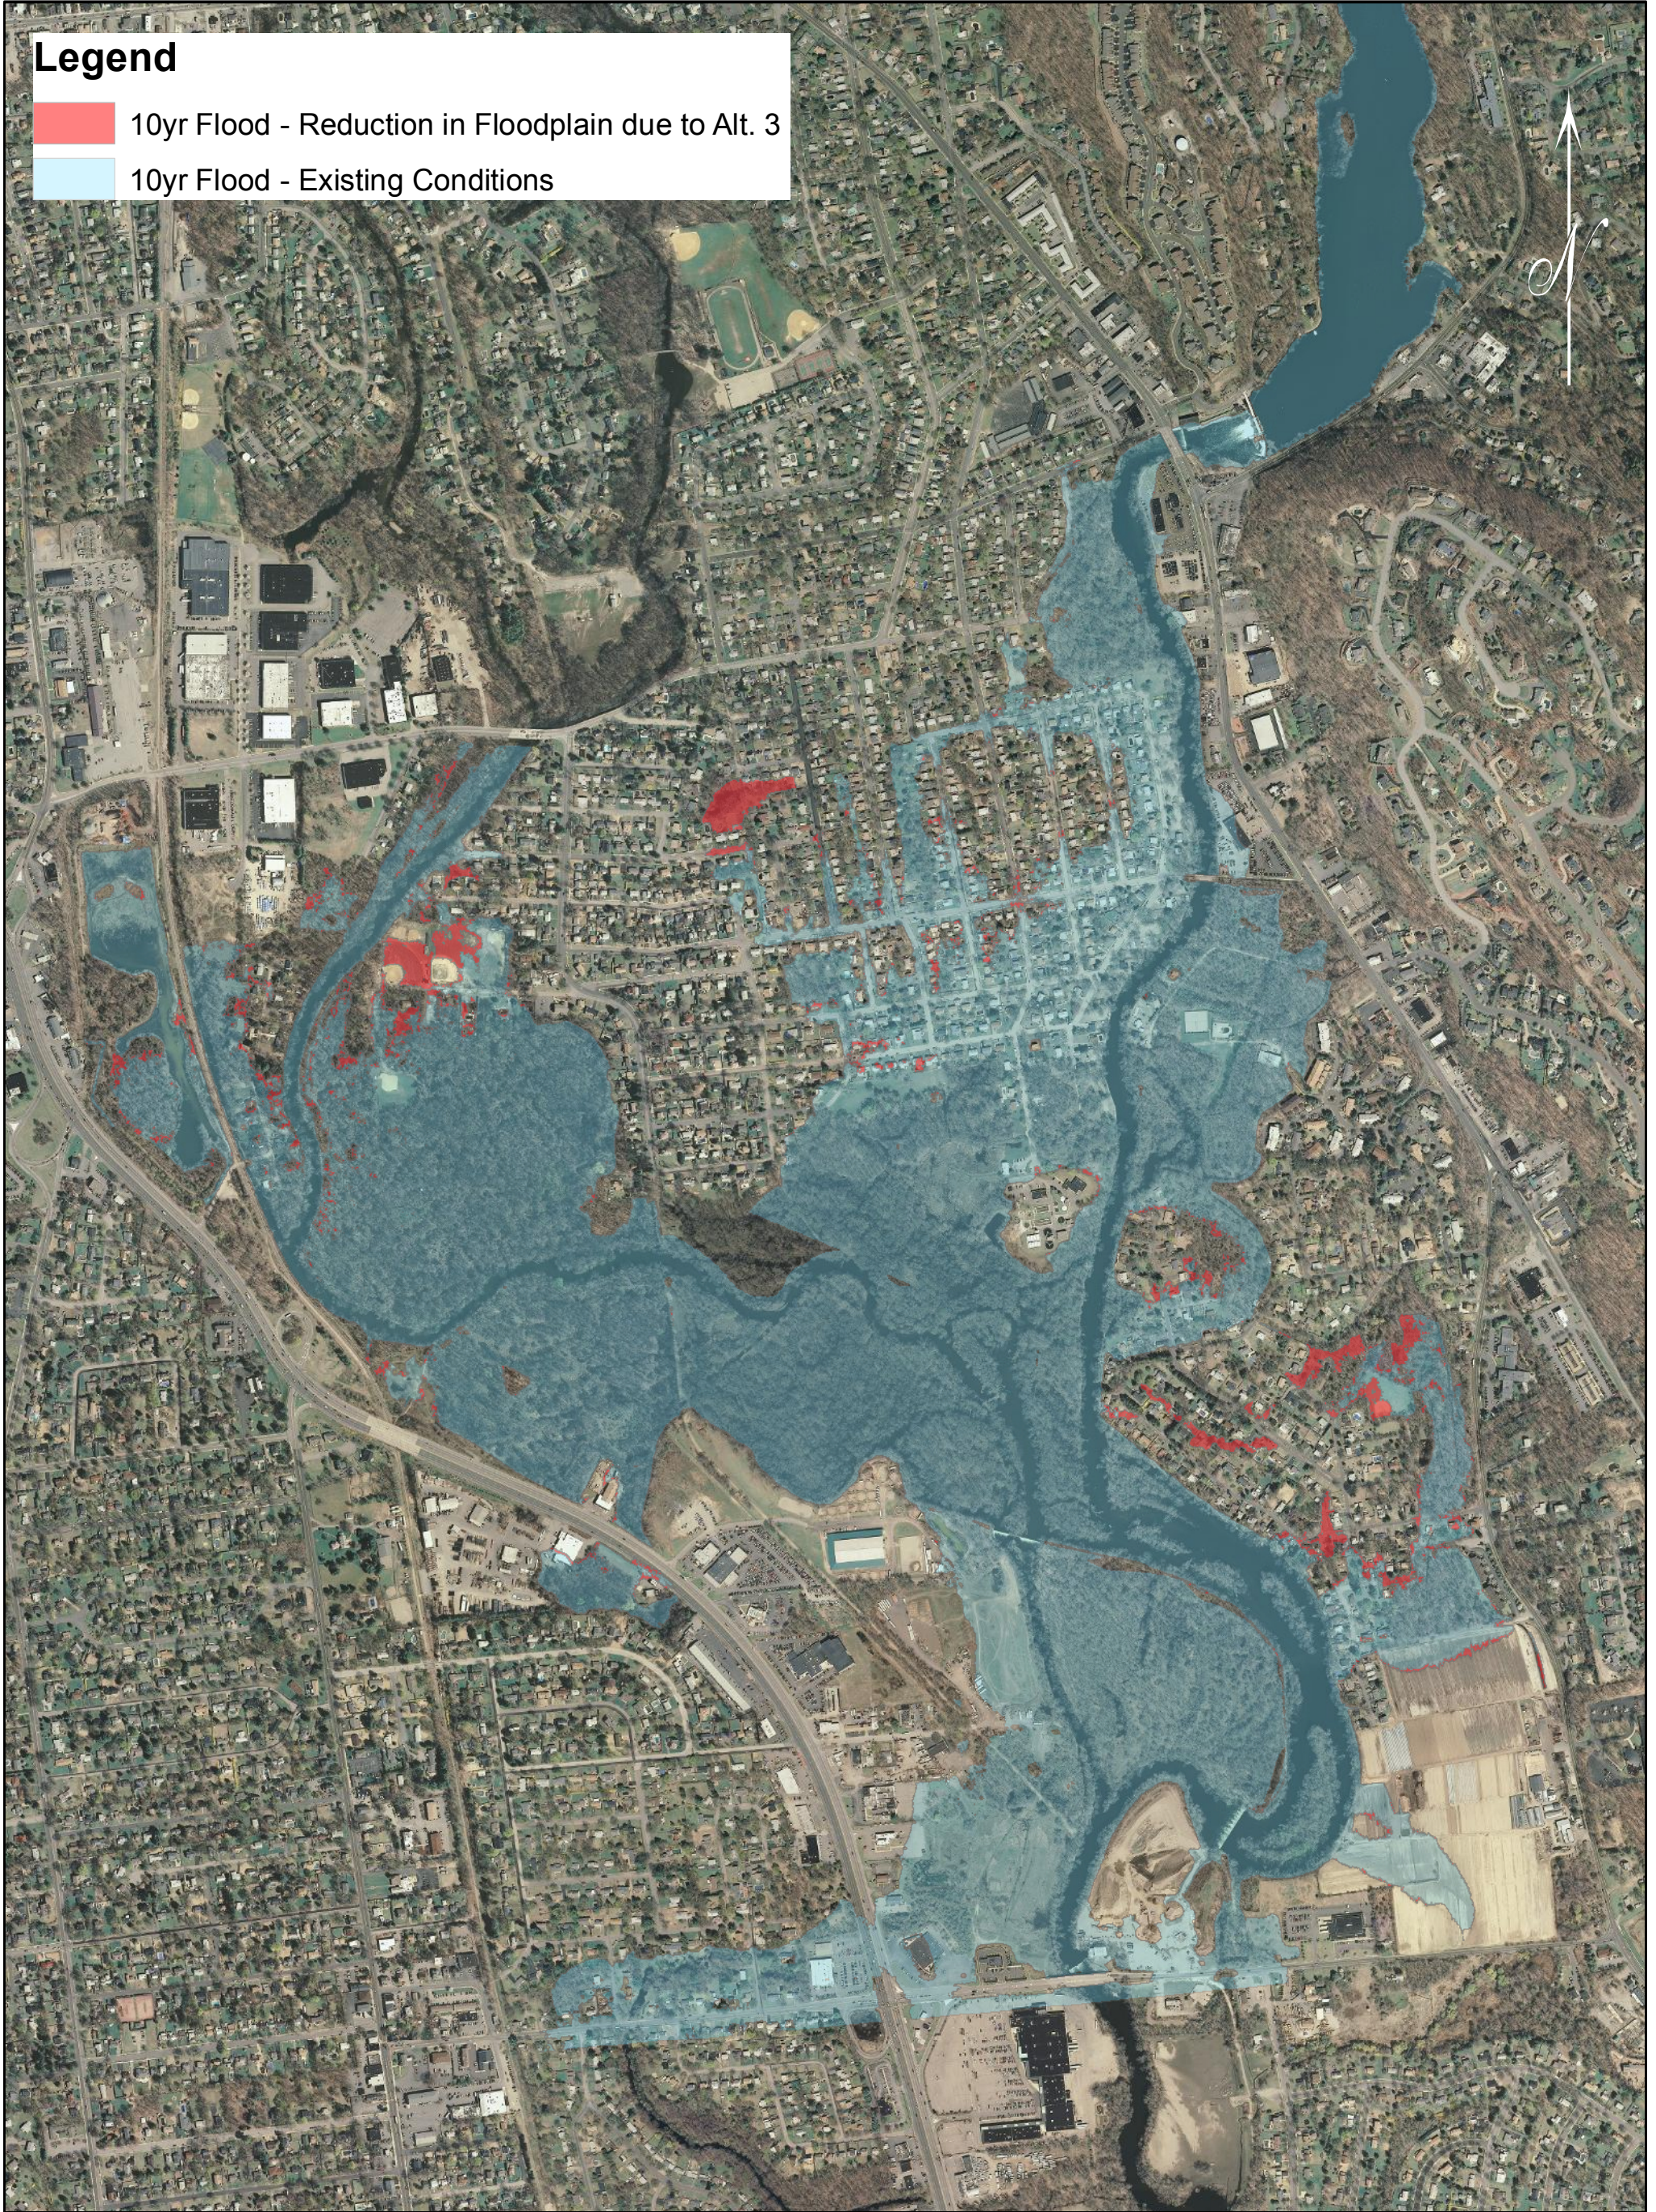
**10-Year Floodmap - Reduction in Floodplain due to Alternative 3**

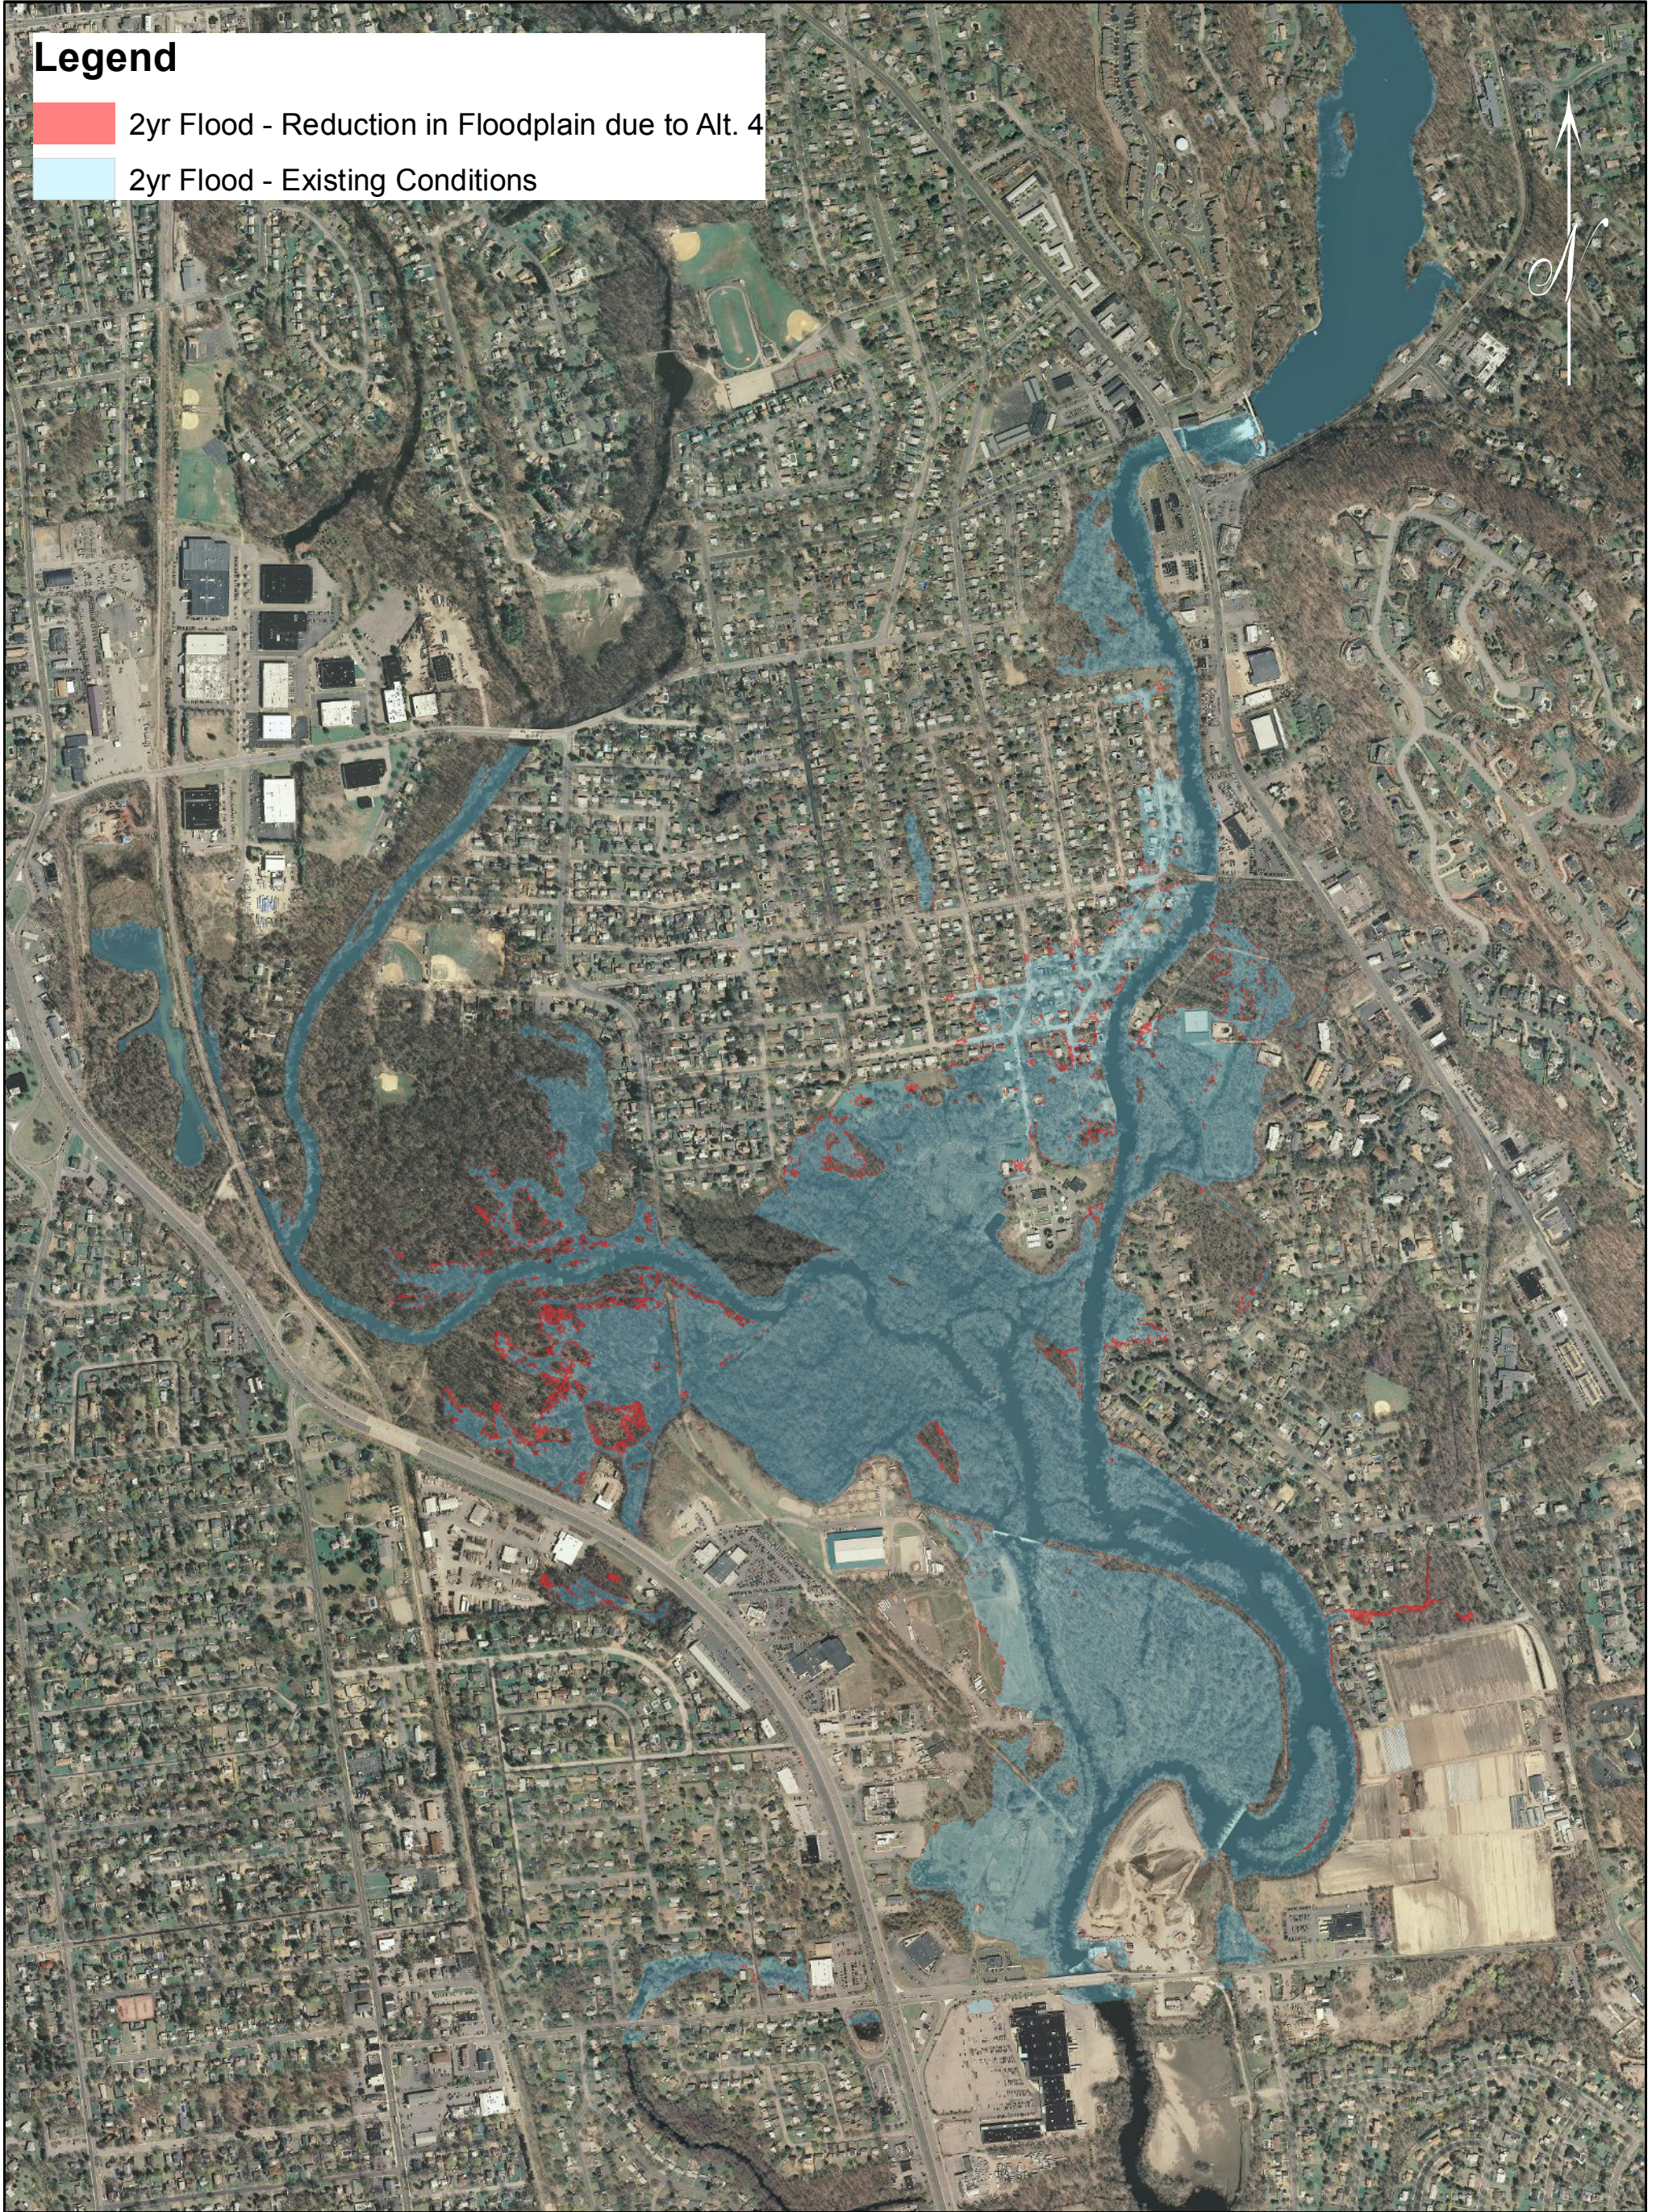
**2-Year Floodmap - Reduction in Floodplain due to Alternative 4**

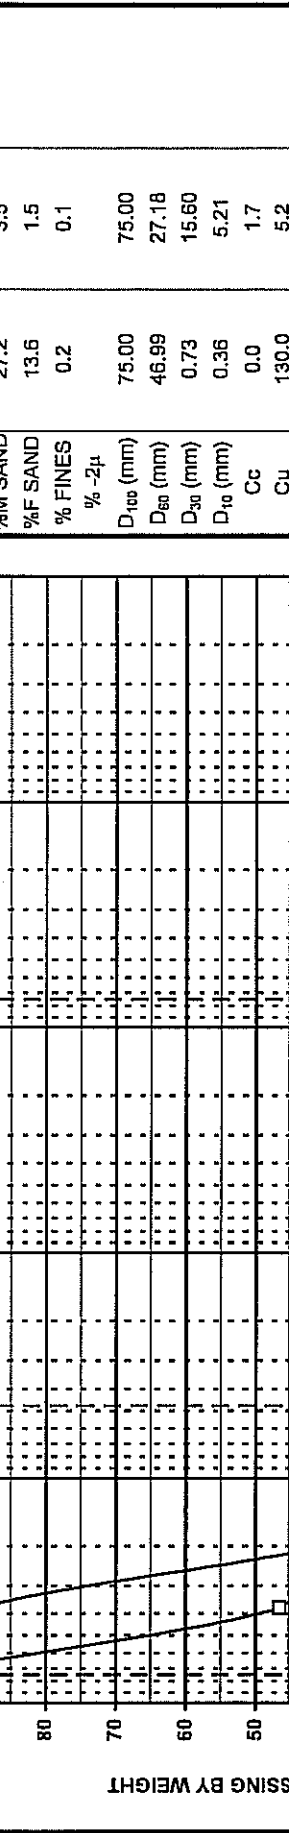
Symbol	GRAVEL		SAND			Section 4 Right	Section 6 Left
	COARSE	FINE	COARSE	MEDIUM	FINE		
Boring							
Sample Depth							
% +3"						0.0	0.0
% Gravel						58.6	90.8
% SAND						41.2	9.1
% C SAND						0.3	4.2
% M SAND						27.2	3.5
% F SAND						13.6	1.5
% FINES						0.2	0.1
% -2 $\mu$							
D <sub>100</sub> (mm)						75.00	75.00
D <sub>60</sub> (mm)						46.99	27.18
D <sub>30</sub> (mm)						0.73	15.60
D <sub>10</sub> (mm)						0.36	5.21
Cc						0.0	1.7
Cu						130.0	5.2

Particle Size (Sieve #)	Section 4 Right (%)	Section 6 Left (%)
4"	100.0	100.0
3"	46.5	89.0
1 1/2"	43.0	37.0
3/4"	41.6	17.4
3/8"	41.4	9.2
4	41.0	5.0
10	36.3	3.3
20	13.9	1.6
40	3.2	0.4
60	0.8	0.1
100	0.2	0.1
200

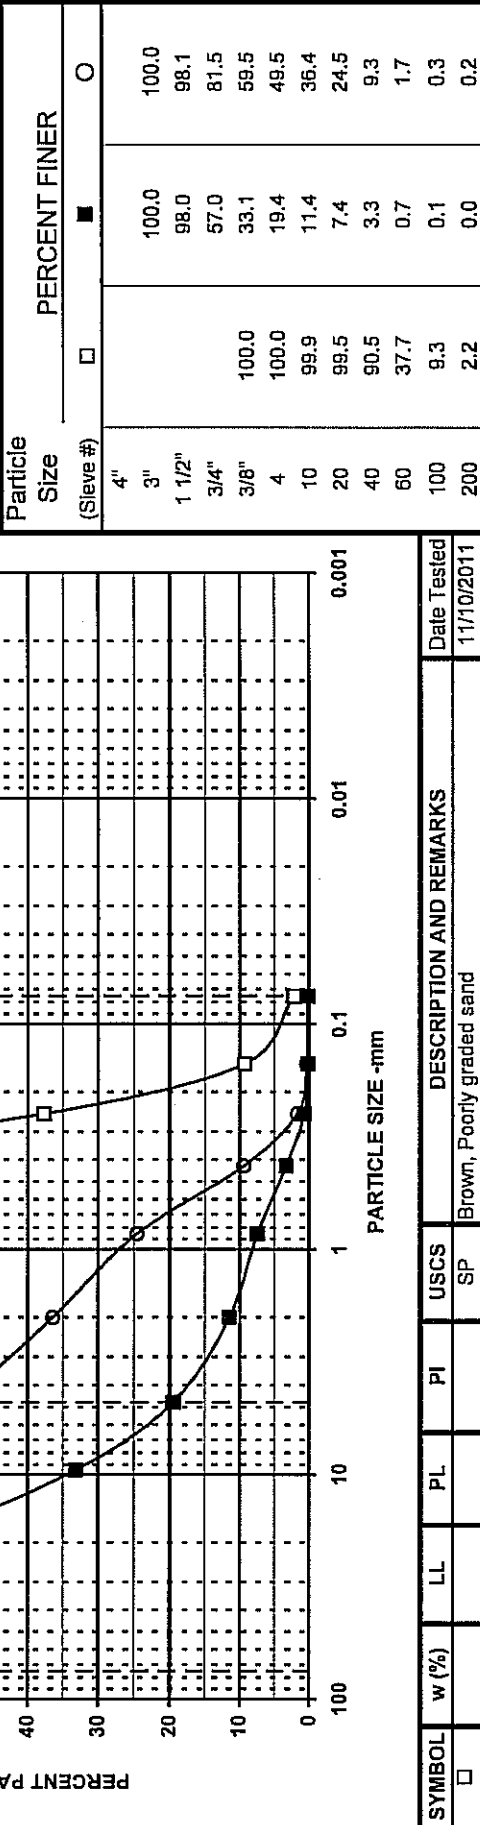
Symbol	Section 7.2 Right	Section 7.5 Center	Section 7.7 Left Side
Boring Sample			
Depth	0.0	0.0	0.0
% +3"	0.0	0.0	0.0
% Gravel	0.0	80.6	50.5
% SAND	97.8	19.4	49.3
%C SAND	0.1	8.0	13.0
%M SAND	9.4	8.2	27.1
%F SAND	88.4	3.2	9.2
% FINES	2.2	0.0	0.2
% -2µ			
D <sub>100</sub> (mm)	9.50	75.00	75.00
D <sub>60</sub> (mm)	0.32	20.35	9.71
D <sub>30</sub> (mm)	0.22	8.41	1.38
D <sub>10</sub> (mm)	0.15	1.59	0.44
Cc	1.0	2.2	0.4
Cu	2.1	12.8	21.9

Symbol	w (%)	LL	PL	PI	USCS	DESCRIPTION AND REMARKS	Date Tested
□					SP	Brown, Poorly graded sand	11/10/2011
■					GW	Brown, Well-graded gravel with sand	11/10/2011
○					GP	Brown, Poorly graded gravel with sand	11/10/2011

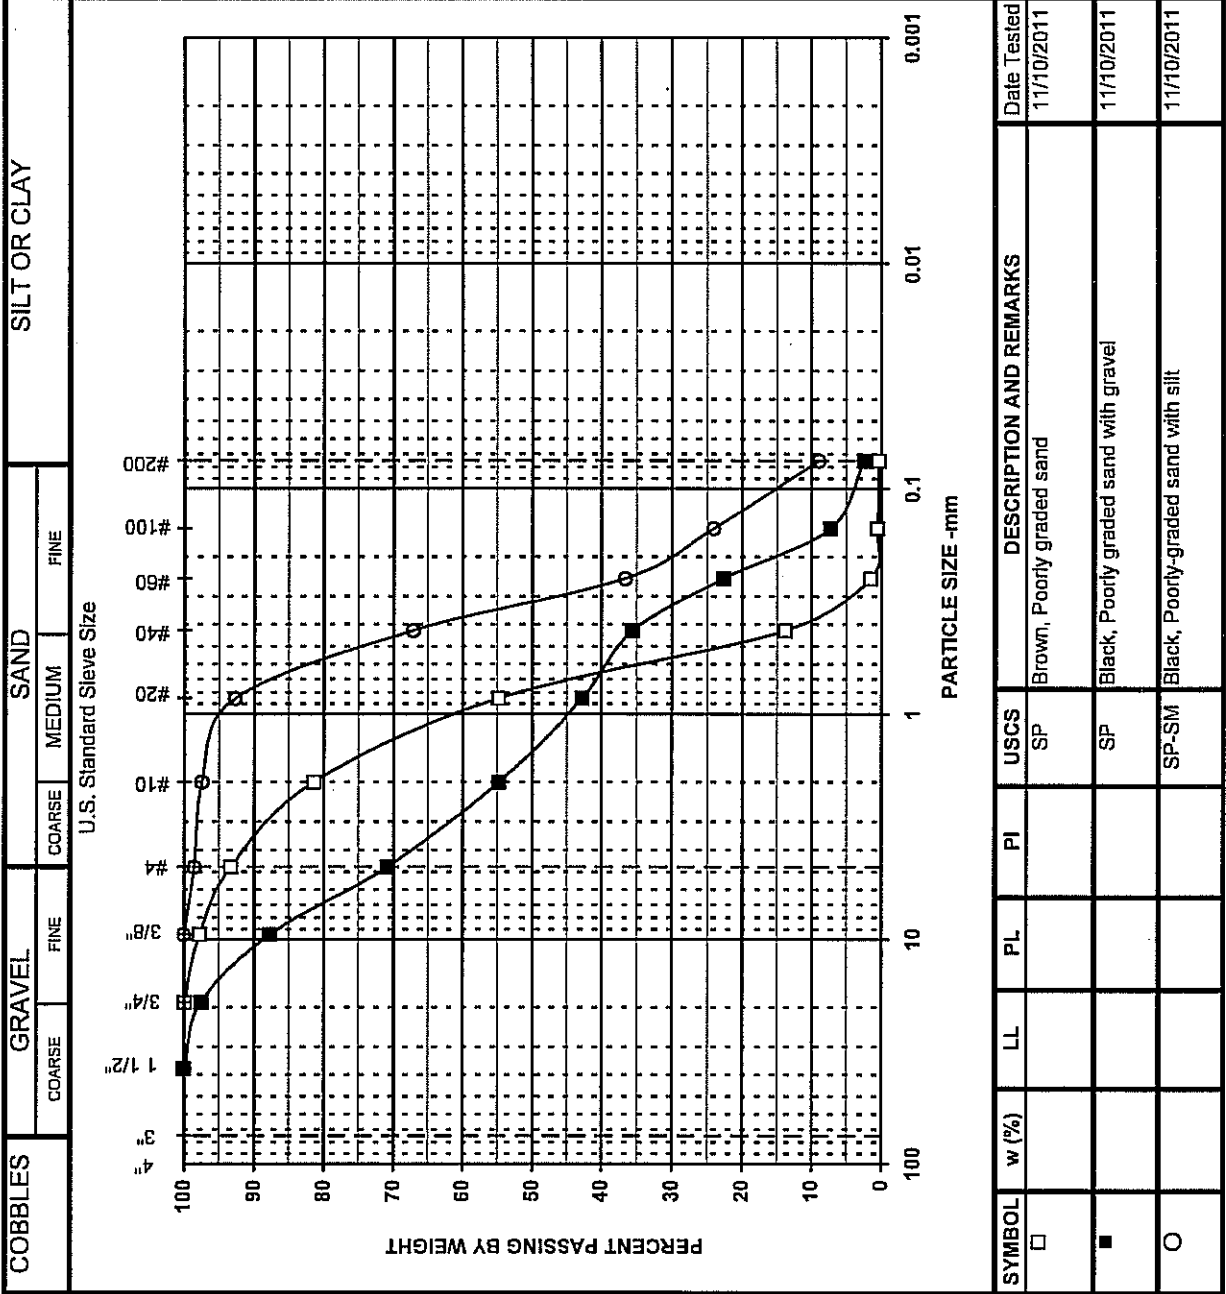
Symbol	SILT OR CLAY			Section 9.2 Center				
	COBBLES	GRAVEL	SAND					
Boring Sample Depth	COARSE	FINE	COARSE	MEDIUM	FINE	Section 8 Center	Section 9 Right Center	Section 9.2 Center
% +3"						0.0	0.0	0.0
% Gravel						6.6	29.1	1.5
% SAND						93.1	68.5	89.6
% C SAND						11.9	16.1	1.1
% M SAND						67.7	19.2	30.3
% F SAND						13.4	33.1	58.2
% FINES						0.3	2.4	8.9
% -2 $\mu$								
D <sub>100</sub> (mm)						37.50	37.50	9.50
D <sub>60</sub> (mm)						1.08	2.90	0.38
D <sub>30</sub> (mm)						0.59	0.35	0.20
D <sub>10</sub> (mm)						0.37	0.17	0.08
Cc						0.9	0.3	1.3
Cu						2.9	17.3	4.8

SYMBOL	w (%)	LL	PL	PI	USCS	DESCRIPTION AND REMARKS		Date Tested
						USCS	REMARKS	
□					SP	Brown, Poorly graded sand		11/10/2011
■					SP	Black, Poorly graded sand with gravel		11/10/2011
○					SP-SM	Black, Poorly-graded sand with silt		11/10/2011

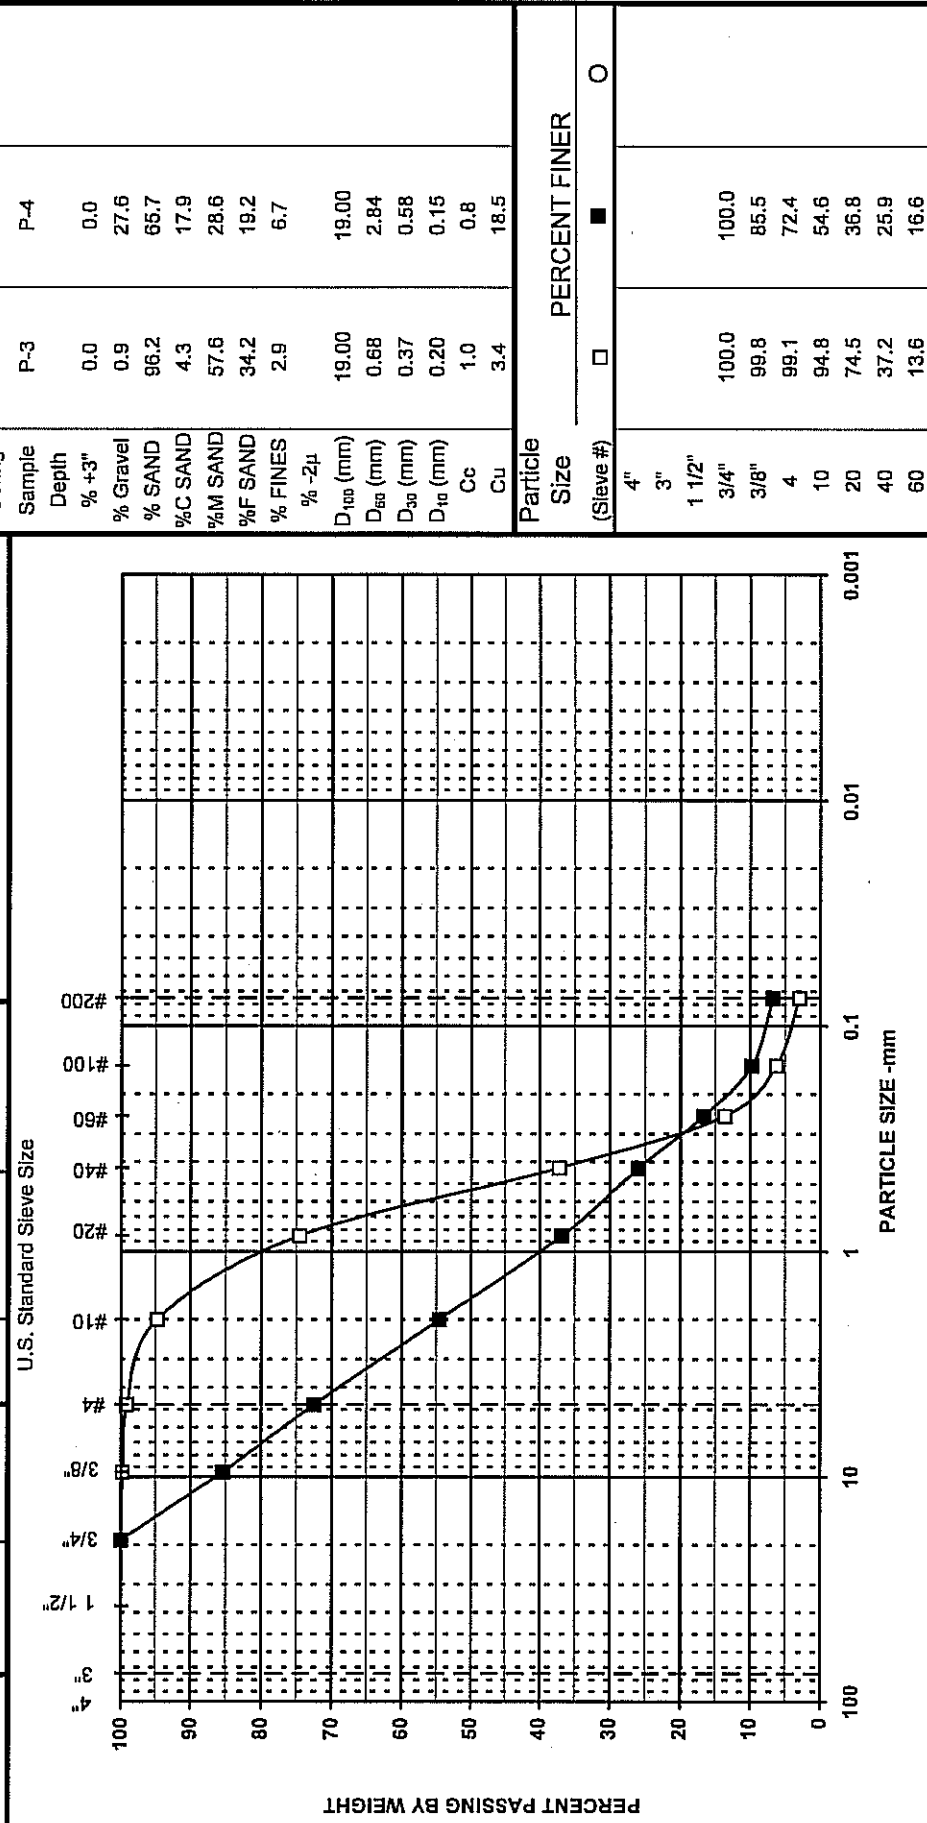
SYMBOL	□	■	○
	P-3	P-4	
Boring			
Sample Depth			
% +3"	0.0	0.0	
% Gravel	0.9	27.6	
% SAND	96.2	65.7	
% C SAND	4.3	17.9	
% M SAND	57.6	28.6	
% F SAND	34.2	19.2	
% FINES	2.9	6.7	
% -2µ			
D <sub>100</sub> (mm)	19.00	19.00	
D <sub>60</sub> (mm)	0.68	2.84	
D <sub>30</sub> (mm)	0.37	0.58	
D <sub>10</sub> (mm)	0.20	0.15	
Cc	1.0	0.8	
Cu	3.4	18.5	
Particle Size (Sieve #)	□	■	○
PERCENT FINER			
4"			
3"			
1 1/2"			
3/4"	100.0	100.0	
3/8"	99.8	85.5	
4	99.1	72.4	
10	94.8	54.6	
20	74.5	36.8	
40	37.2	25.9	
60	13.6	16.6	
100	6.2	9.8	
200	2.9	6.7	
TerraSense, LLC		Civil Dynamics	
7889-11004		#258	
PARTICLE SIZE DISTRIBUTION			
Pomptom-Pequanock Dams - Pequannock River
